# **COGEAR**

### **Geotechnical investigations at the instrument borehole sites**

**Del. No.: 3b.2.3.1**

**Engineering Geology, ETH Zürich**

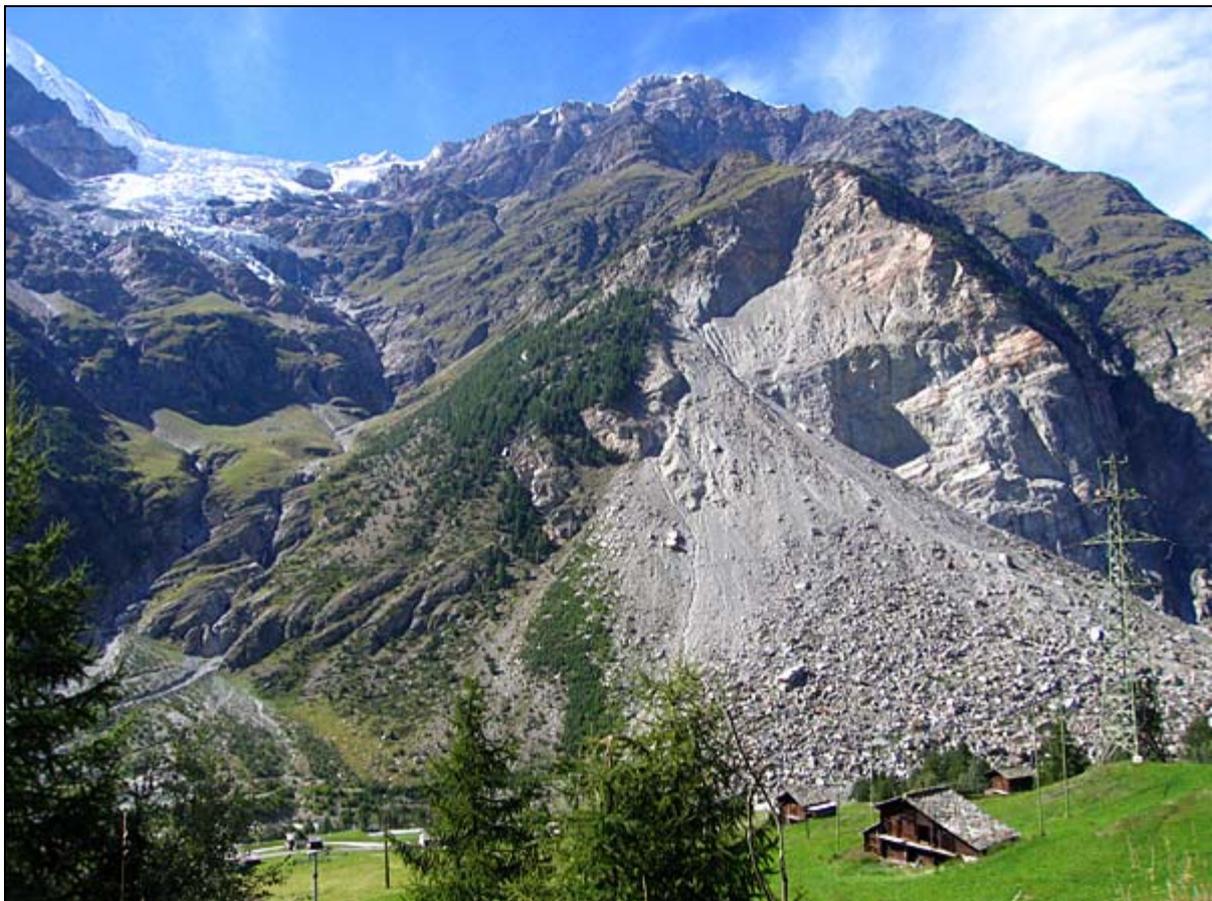
In April and May of 1991, two consecutive rockslides occurred from a cliff high above the village of Randa in the Matter Valley of Switzerland (Figures 1 and 2). These complex rockslides released a cumulative volume of approximately 30 million m<sup>3</sup> of crystalline rock, with each of the rockslide stages occurring over several hours (Schindler et al., 1993). Slide debris buried important transportation lines including the road and railway leading to Zermatt, and dammed the Matternvispa River which flooded a portion of the upstream town of Randa. No fatalities resulted from either rockslide event.

**Figure 2:** Detail of the scarp and deposit of the 1991 failures at Randa.

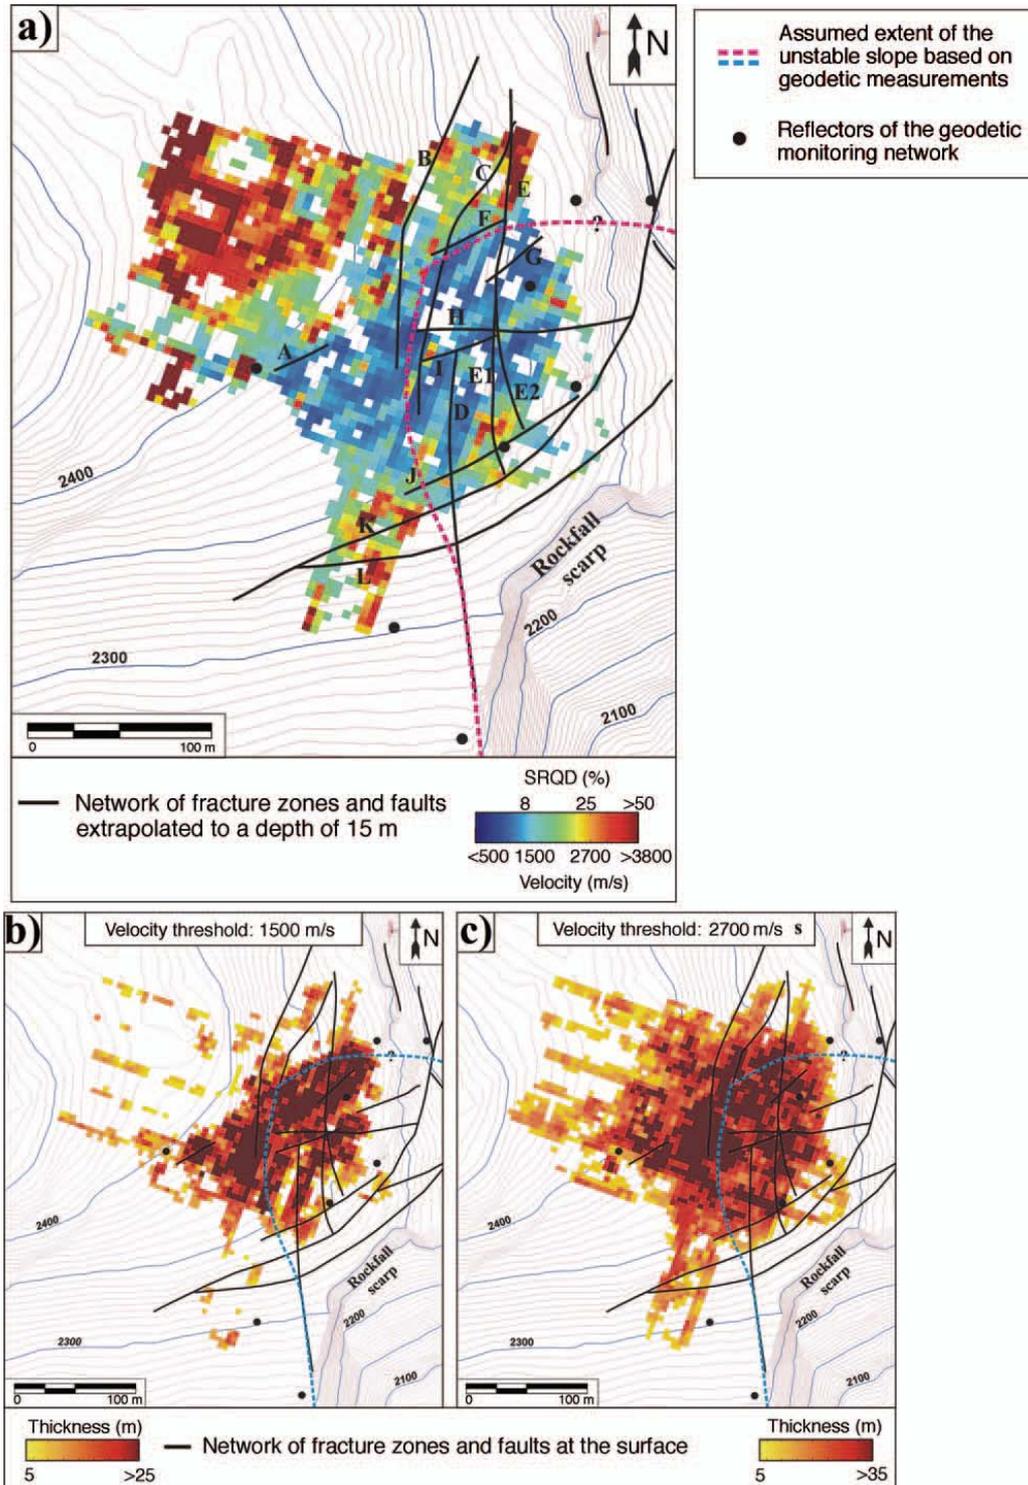
A new 3D tomographic seismic refraction technique was developed to determine the P-wave velocity structure of the unstable and adjacent parts of the rockslide (Figure 4). Inversion of first-arrival travel time picks revealed a broad zone of remarkably low seismic velocities (less than 1500 m/s). This ultra-low velocity zone extended to a depth of at least 25 m over a 200 x 100 m area significantly beyond the limits of the rock mass that is known to be currently moving. To explain such low velocities requires 17% of the investigated volume to be air-filled voids. Several faults transect the ultra-low velocity region, the trend of which paralleled part of the scarp generated by the 1991 rockslide events. Ubiquitous dry cracks, fracture zones, and faults are the likely cause of the anomalously low velocities. For full details and further information, the reader is referred to Heincke (2005) and Heincke et al. (2006a).

**Figure 4:** (a) P-wave velocity distribution determined from 3D seismic refraction tomography; (b) and (c) thickness of different low-velocity zones. Figure reproduced from Heincke et al. (2006a).

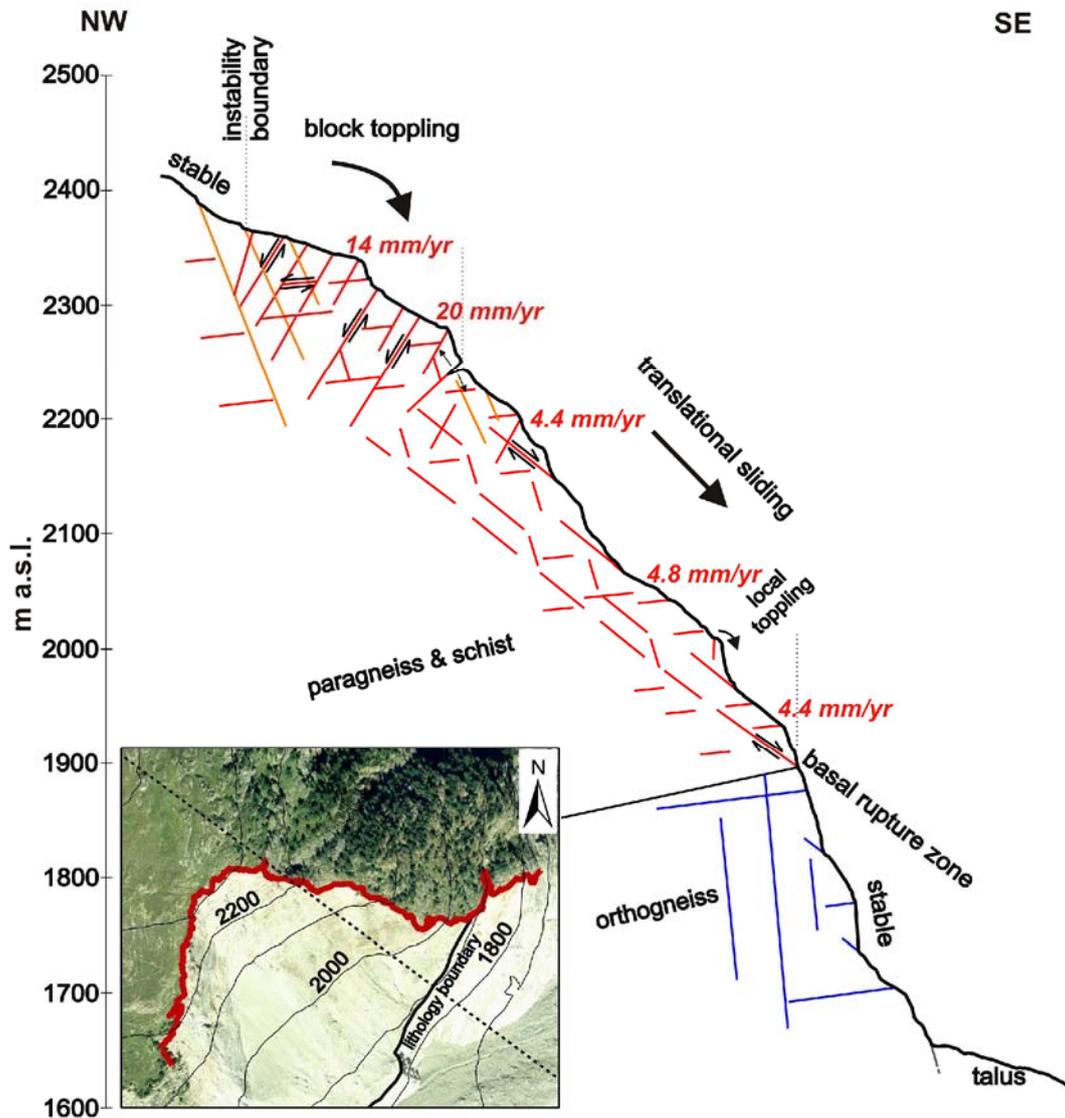
The cumulative results of this integrated geological / geophysical characterization of the 3D rock mass structure at Randa is thoroughly reported by Willenberg, 2004 and Willenberg, 2008a, and the reader is referred to these manuscripts for more detailed information. A cross-section through the geological model of the unstable rock mass, showing interpreted kinematic modes of failure and displacement rates derived from the most recent investigations, is shown in Figure 6.

**Figure 6:** Cross-section through the currently unstable rock mass at Randa showing Conceptual 2-D kinematic model of the instability. Block toppling observed in the upper part of the instability changes to translation sliding in lower areas, and a basal rupture surface can be definitively observed. Figure reproduced from Gischig et al. (2009). Velocities indicated are the displacement rates derived from GB-DInSAR.

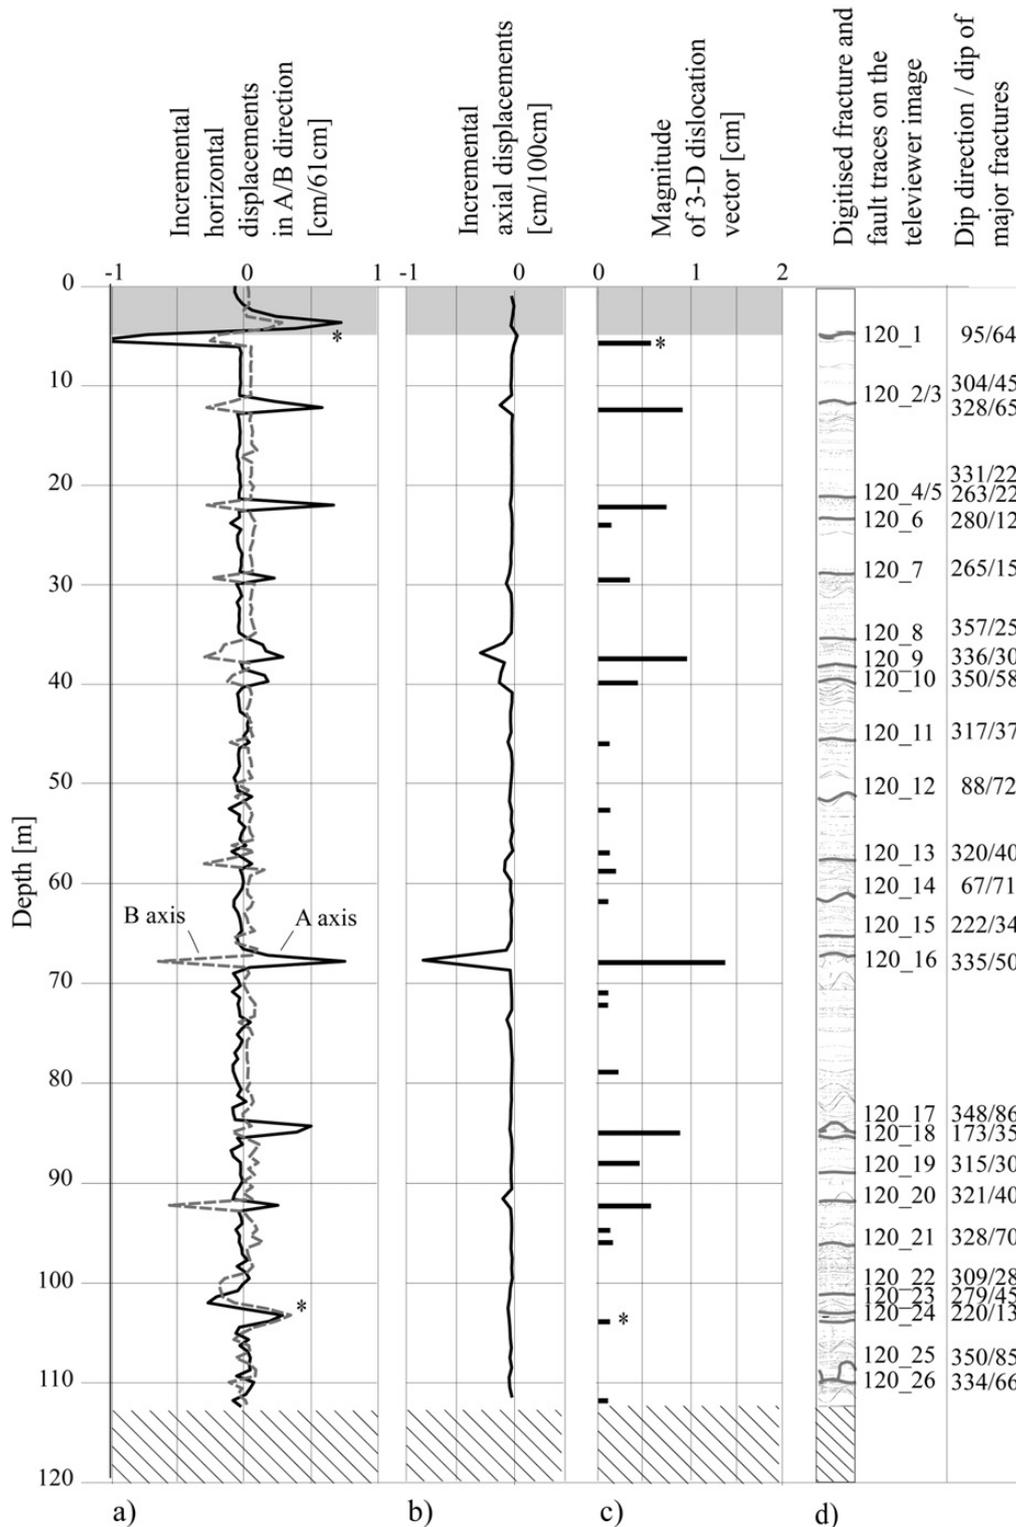
Periodic inclinometer surveys were performed twice per year from 2002 through 2006, and more sparsely thereafter. All inclinometer surveys used a 61 cm base length, bi-axial instrument. Results for borehole sb120 are presented in Figure 9, and have been used to identify actively deforming faults along the borehole axis, and characterize their rates of displacement. Extensometer surveys using the INCREX system were performed in conjunction with inclinometer measurements twice per year. The sensor base length (and measurement interval) was 60 cm. Results are shown in Figure 9, and are again used to help characterize active faults and their axial displacement rates. Two in-place inclinometers were installed across discontinuities at 68 m and 85 m depth in borehole sb120. Their purpose was to monitor continuous deformations across these selected discontinuities and to detect any temporal changes in the displacement rate. The locations were chosen according to periodic inclinometer surveys, which showed significant displacement across the chosen faults. The in-place inclinometers were operational between January 2004 and August 2008, and were then upgraded with new fiber optic instruments (described below). Detailed description of these measurement systems and a full discussion of the results can be found in Willenberg (2004) and Willenberg et al. (2008a,b).

The traces of major fractures revealed with televiewer imaging in borehole sb120 are shown together with their resolved orientations in Figure 9. These fractures have widths greater than 2 mm and tend to contain intensely foliated material. The fractures are shown with the horizontal and axial displacement profiles derived from inclinometer and extensometer surveys, and the magnitude of the derived 3D displacement vector is also noted (for explanation of the analysis procedure see Willenberg, 2004). Results suggest that deformation is highly localized along certain identified faults. Regions of high fracture density (i.e. more than 3 fractures per 0.61 m) generally do not exhibit distributed displacement. Thus, internal deformation of the rock mass is accommodated primarily by dislocation of the active major faults. In Figure 10, the same fracture image and orientation data are shown together with summary results from borehole geo-radar surveying. Fractures are grouped into sets where possible. Correlations between geo-

**Figure 9:** Summary of inclinometer, extensometer, and televiewer results for borehole sb120. Horizontal and axial displacements along the identified fault zones are shown, as well as the 3D magnitude and structure orientation. Figure reproduced from Willenberg et al. (2008b).

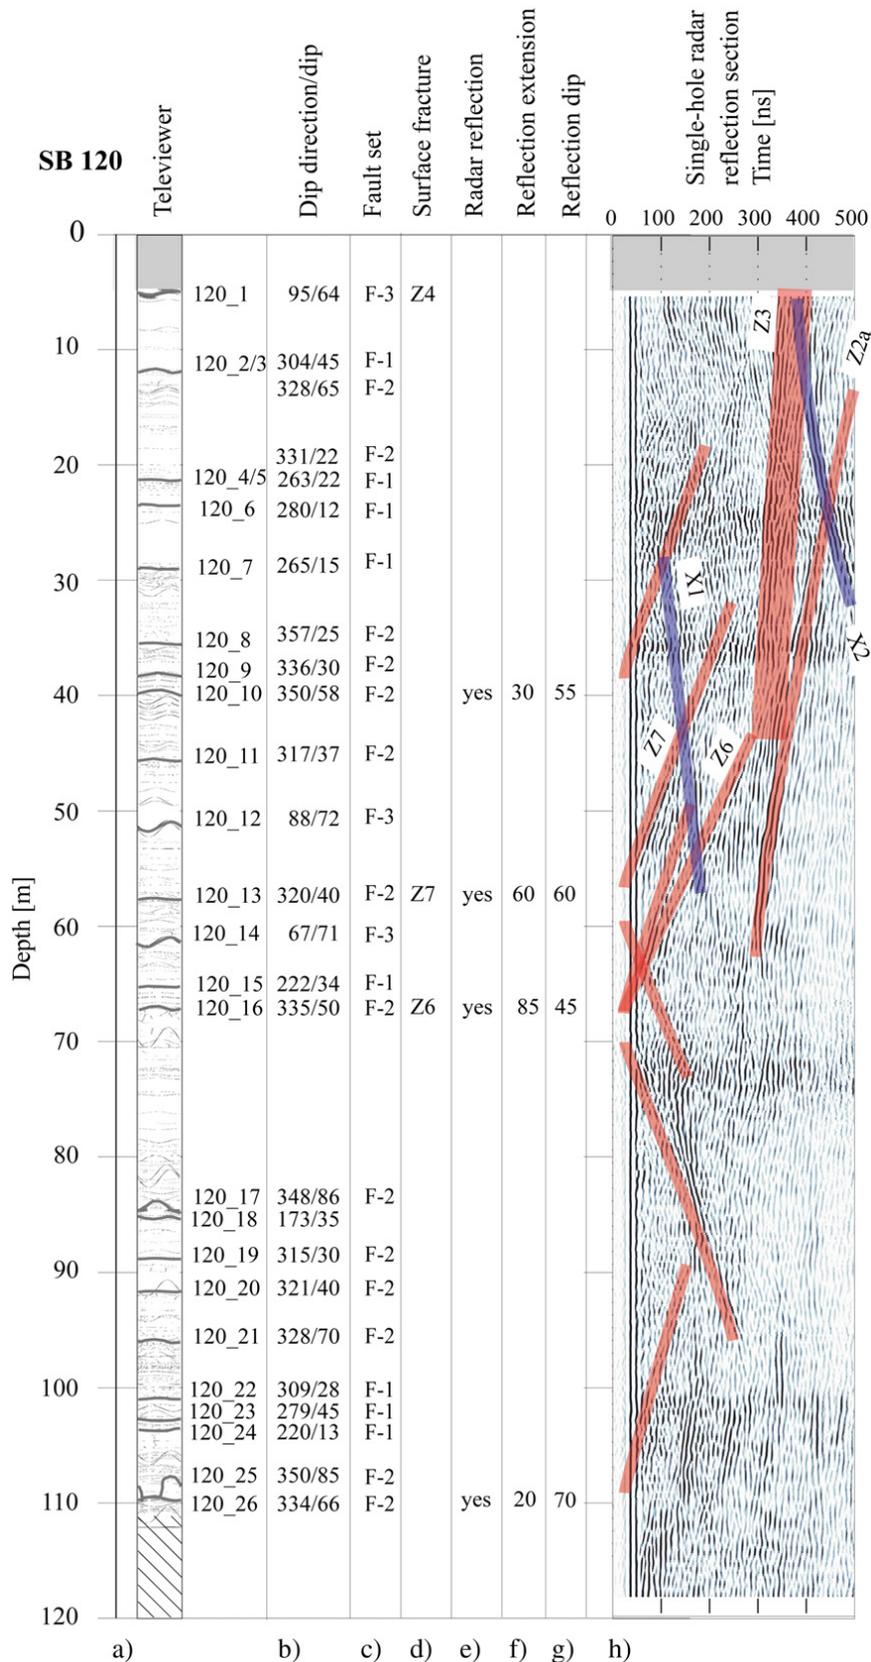
radar reflections and televiwer imaging are apparent, and the most important reflections are highlighted and labeled.

**Figure 10:** Comparison of borehole televiewer mapping and borehole fracture surveys with borehole geo-radar data. The orientations of labeled fractures are shown, as well as their respective fault set association. Figure reproduced from Willenberg et al. (2008a).

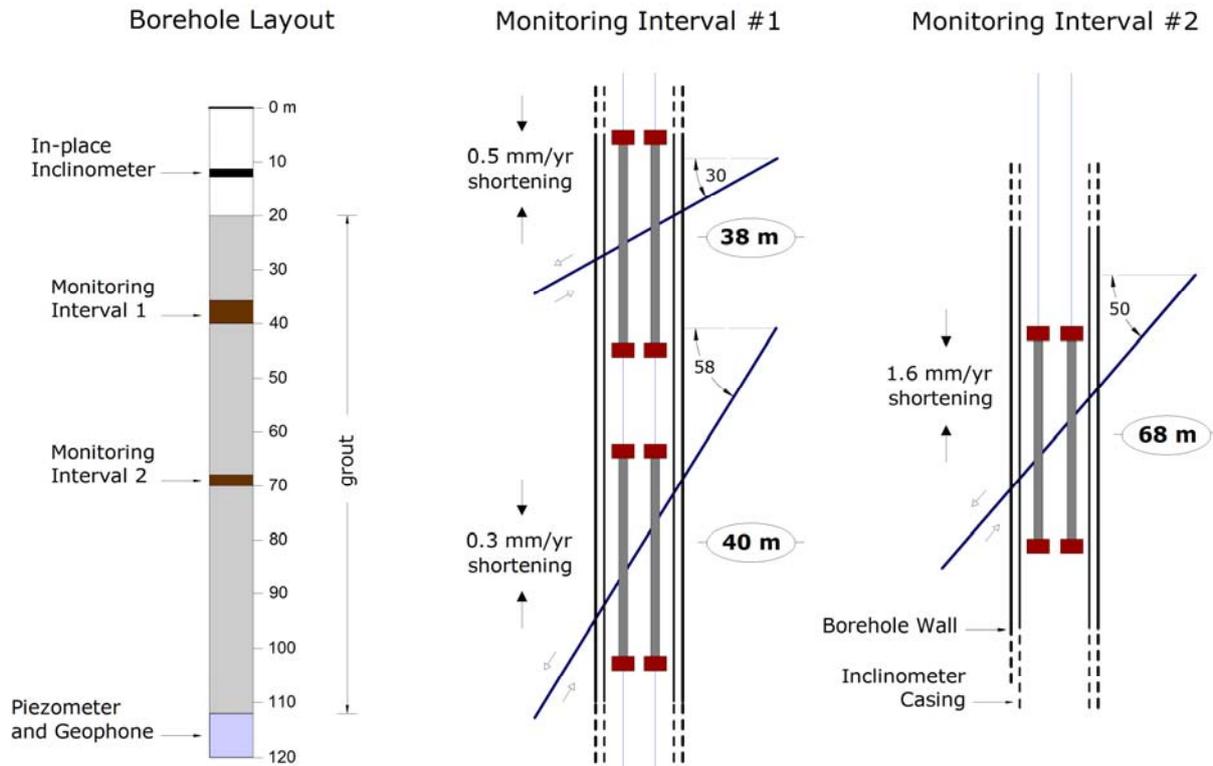
**Figure 11:** Detail of fiber optic sensor installation in borehole sb120. Two monitoring intervals were selected to span three active faults showing normal mode offset (see slip arrows). The expected rates of shortening, calculated from previous extensometer surveys, are shown. Two active parallel sensor chains were installed for redundancy and security, and a third inactive chain (not shown) acts as reserve. Figure reproduced from Moore et al. (2010).

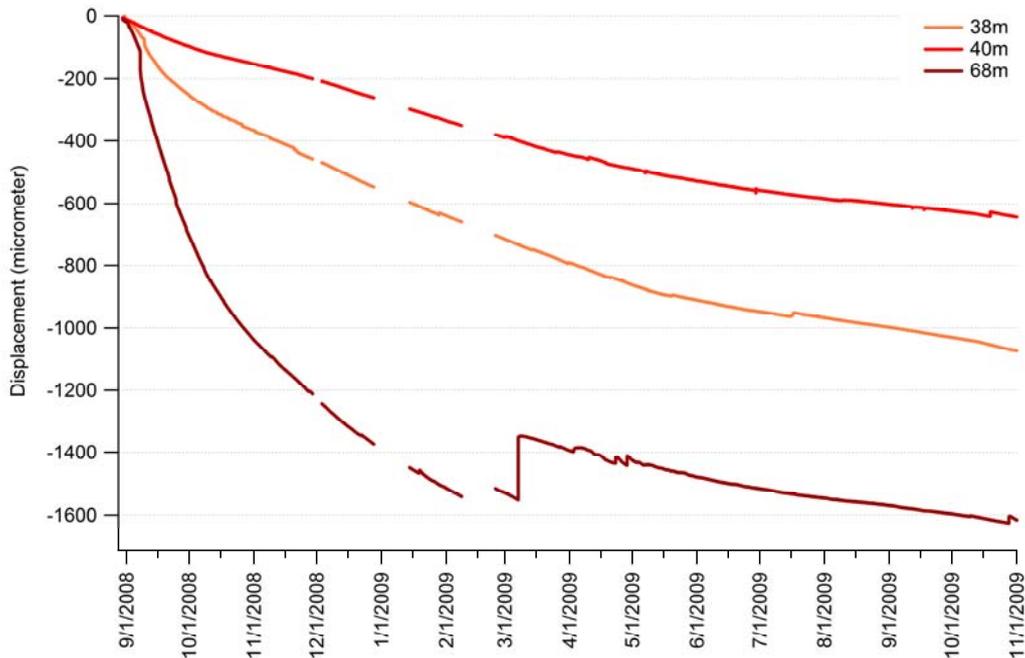
Full system specifications and detailed discussion of first monitoring results can be found in Moore et al. (2010). Relevant results from borehole sb120 are briefly reproduced here. Since installation, the FO monitoring system has been operational more than 90% of the time. Figure 12 shows the time series of measured displacements from the three different monitoring intervals in borehole sb120. All sensors are shortening as expected. Accelerated shortening following installation of the borehole sensors can be clearly observed during the first 2-3 months, and is related to long-term drying shrinkage of the grout. Otherwise, the sensors show deformation rates consistent with previous extensometer surveys (Figure 13). A number of transient signals (brief steps or drops) have been observed, which in some cases were large enough to trigger rapid sampling. The combination of short- and long-term observation offers relevant new insight into the deformation process, as shown for example in Figure 14.

**Figure 12:** Deformation time series measurements from the three sensors at different monitoring intervals in borehole sb120. All sensors are shortening as expected. Accelerated shortening is seen immediately following sensor installation, which likely results from shrinkage of the grout. A number of transient steps and drops occur throughout the time history; one event from April 28, 2009 is highlighted in the following Figure. Dates are m/d/y. Figure reproduced from Moore et al. (2010).

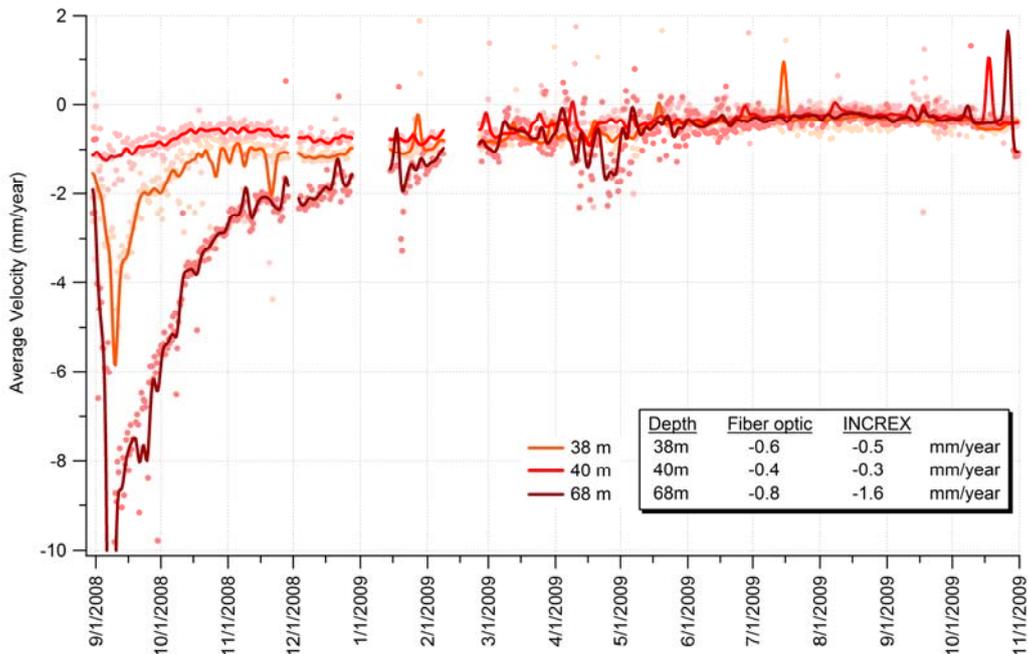
**Figure 13:** Velocity time series for the different sensors in borehole sb120. The inset table shows comparison of the long-term average velocities with those determined from previous INCREX extensometer surveys. Accelerated shortening is clearly visible in the first 2-3 months of operation. Dates are m/d/y. Figure from Moore et al. (2010).

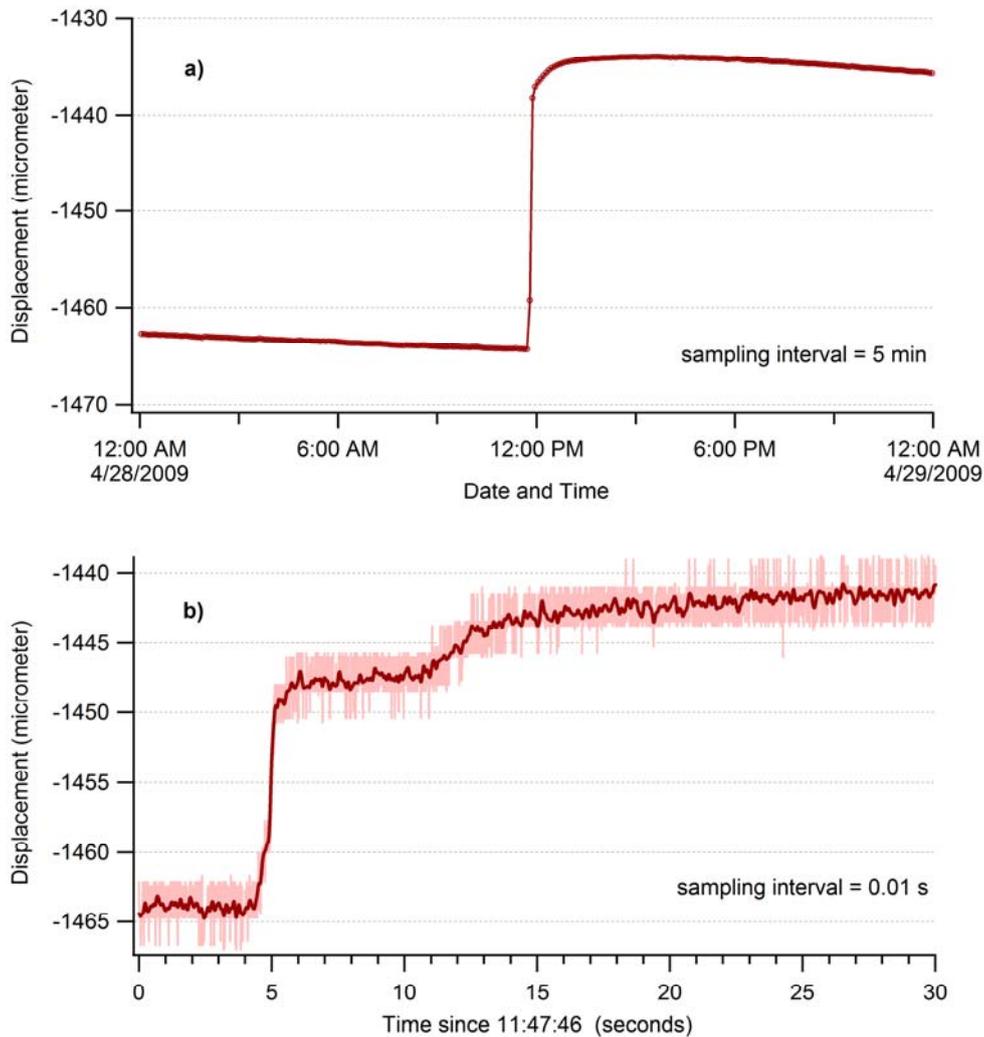
**Figure 14:** a) Expanded view of the transient step occurring on April 28, 2009. The event was a rapid period of axial extension amounting to about  $30 \mu\text{m}$  at the deepest sensor (68 m), contrasting to otherwise steady shortening (see Figure 3). b) The step was large enough to also trigger rapid 100 Hz sampling. Observed details indicate that the majority of deformation occurred through one large step lasting roughly 1 s, and that deformation continued with a smaller, slower step followed by slow continuous extension. Figure reproduced from Moore et al. (2010).
