# **COGEAR**

### **Geotechnical investigations at the instrument borehole sites**

**Del. No.: 3b.2.3.1**

**Engineering Geology, ETH Zürich**

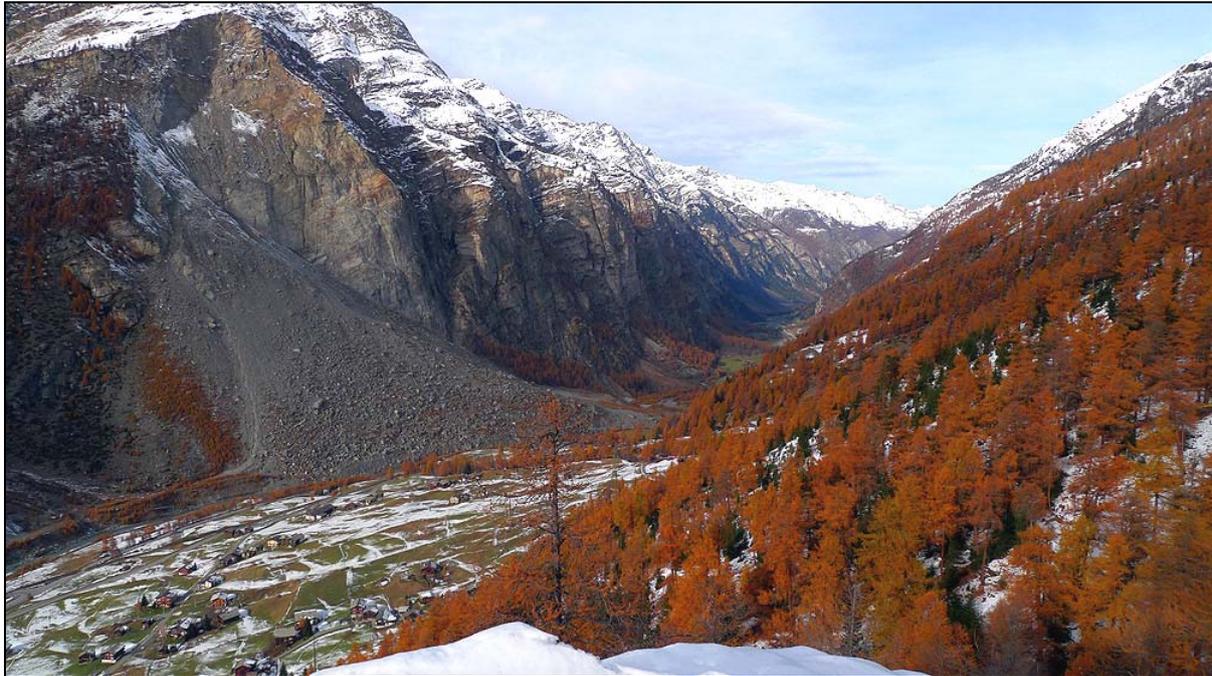
In April and May of 1991, two consecutive rockslides occurred from a cliff high above the village of Randa in the Matter Valley of Switzerland (Figures 1 and 2). These complex rockslides released a cumulative volume of approximately 30 million m<sup>3</sup> of crystalline rock, with each of the rockslide stages occurring over several hours (Schindler et al., 1993). Slide debris buried important transportation lines including the road and railway leading to Zermatt, and dammed the Matternvispa River which flooded a portion of the upstream town of Randa. No fatalities resulted from either rockslide event.

**Figure 1:** Overview of the Randa rockslide deposit in the Matter Valley.

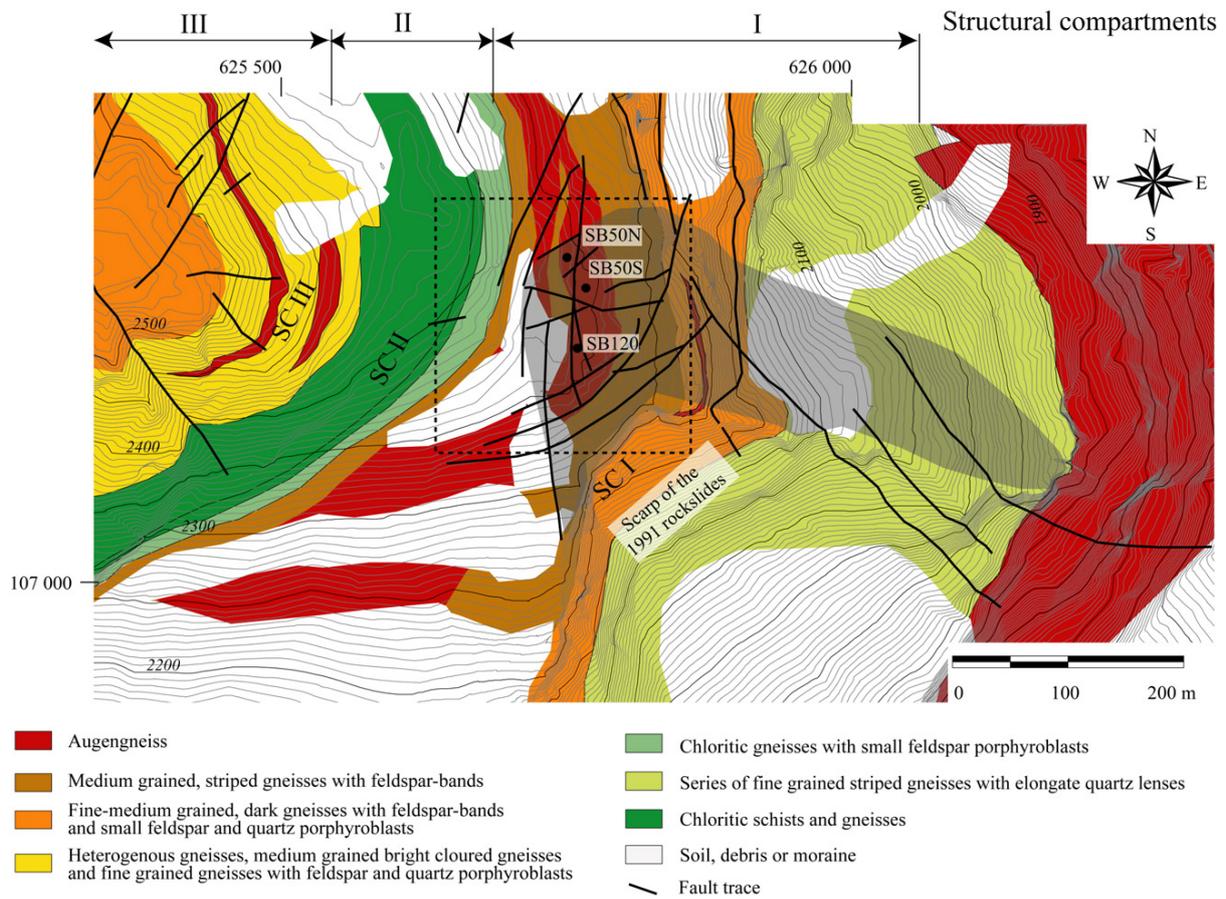
The primary lithologies identified can be grouped into two categories – orthogneiss and paragneiss. The orthogneiss is a competent quartz-rich augengneiss, termed the Randa augengneiss, while the paragneiss is fine grained, contains more micaceous minerals, and is interbedded with chloritic schists (Figure 3). Detailed surface and borehole televiewer mapping revealed that foliation of these gneisses dips primarily to the west, into the slope. Several fracture sets cut the foliation and break the rock mass into blocks. Two scales of discontinuity networks were recognized: a small-scale network consisting of fractures with lengths of up to 5 m, and a large-scale network of faults and fracture zones. The large-scale fracture network includes fracture zones, brittle faults and brittle-ductile shear zones that dip either parallel to foliation to the W or steeply inclined to the E and NW. Similar to the small-scale fracture network, no faults dip at unfavorable angles out of the slope. For additional information and full details, the reader is referred to Willenberg (2004) and Willenberg et al. (2008a).

**Figure 3:** Geological and structural map of the area above and behind the scarp of the 1991 rockslides. Traces of surface faults and fracture zones are shown. Figure reproduced from Willenberg et al. (2008a).

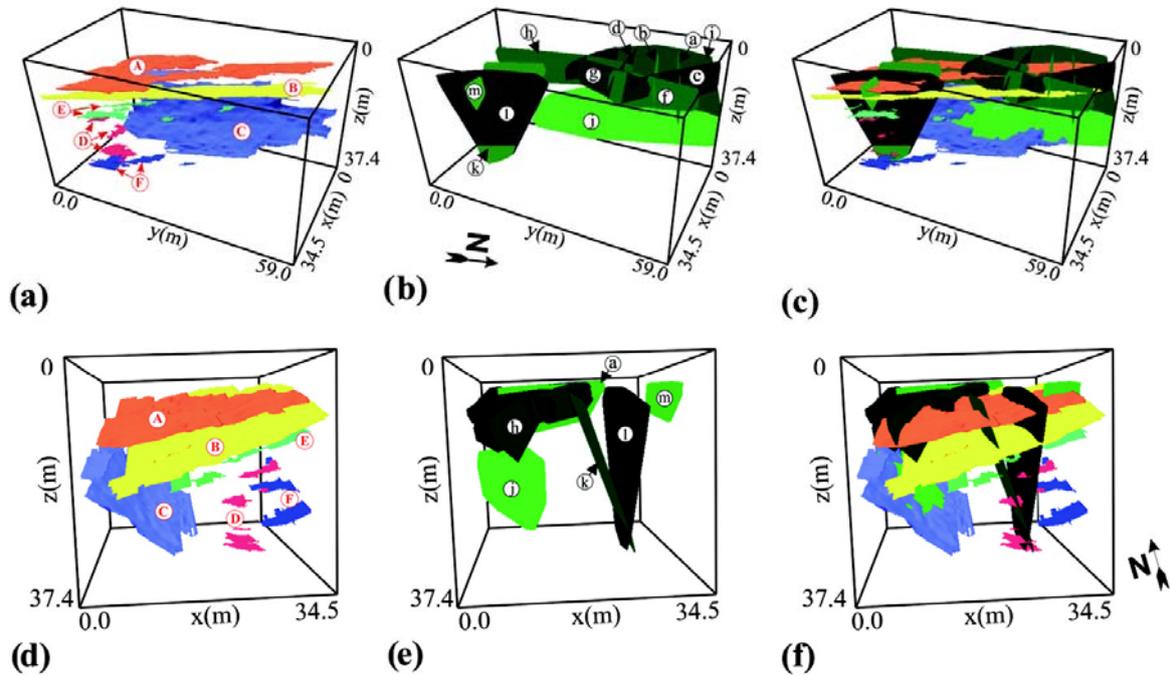
Borehole geo-radar experiments involved single-hole reflection surveys using a 100 MHz antenna system (Figure 5). Several hyperbolic reflections measured in three deep boreholes could be associated with planar fractures. Using velocity values obtained from a cross-hole experiment, the reflection travel times corresponding to the major fractures delineated in the televiewer log were predicted. Six out of the twenty predictions could be associated with hyperbolic reflection patterns observed in the geo-radar section. In addition, it was found that an important feature of the geo-radar data is the capability to determine the minimal extension of the major faults from hyperbolic reflection patterns. Applying basic migration principles to pattern end points, minimum extensions between 7.8 and 49 m were determined. For full details and further information, the reader is referred to Heincke et al. (2006b) and Spillmann et al. (2007b).

**Figure 5:** Results of 3D geo-radar surveying used to identify planar surfaces representing different faults and fracture zones. Parts (c) and (f) are the combination of information in (a) and (b), and (d) and (e), respectively. Figure reproduced from Heincke et al., 2006b).

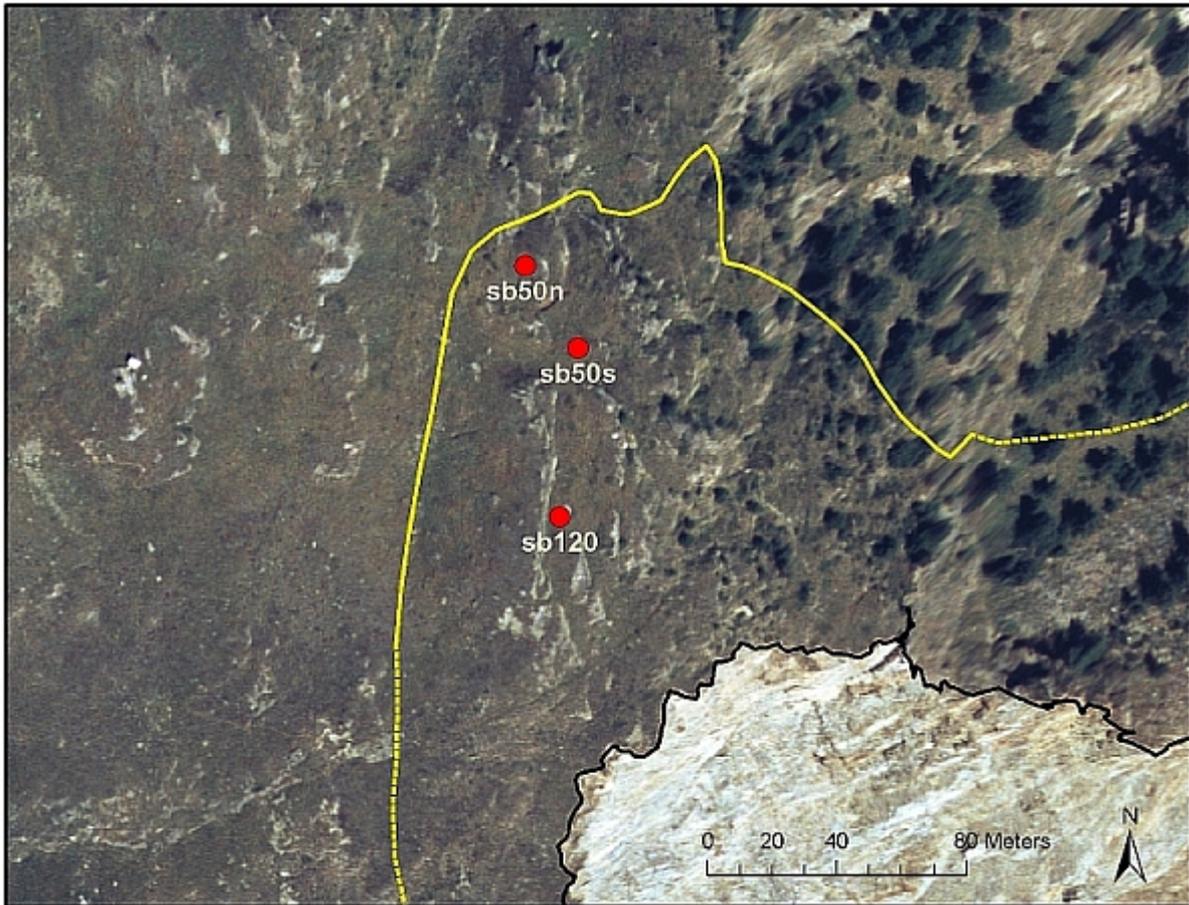
Three deep boreholes were drilled at Randa during creation of the in-situ laboratory. Two boreholes penetrate to 50 m depth (sb50s and sb50n) while the third reaches a depth of 120 m (sb120). Figure 7 shows a layout of the three boreholes within the unstable rock mass. Each borehole is equipped with monitoring casing for periodic inclinometer surveys, piezometers and geophones encased in grout at the hole bottom, and each was logged with a borehole televiewer shortly after drilling. Borehole sb120 is also fitted with external brass rings at regular intervals for extensometer surveying using the INCREX system. Borehole sb120 (Figure 8) was chosen as the site to receive COGEAR instrumentation based on its ideal location within the unstable rock mass, the breadth and quality of information available, and the long existing time series of measurements.

**Figure 7:** Overview of the three deep boreholes at the Randa in-situ laboratory. The number in the name indicates the borehole depth. Yellow line shows the suspected boundary of the current instability.

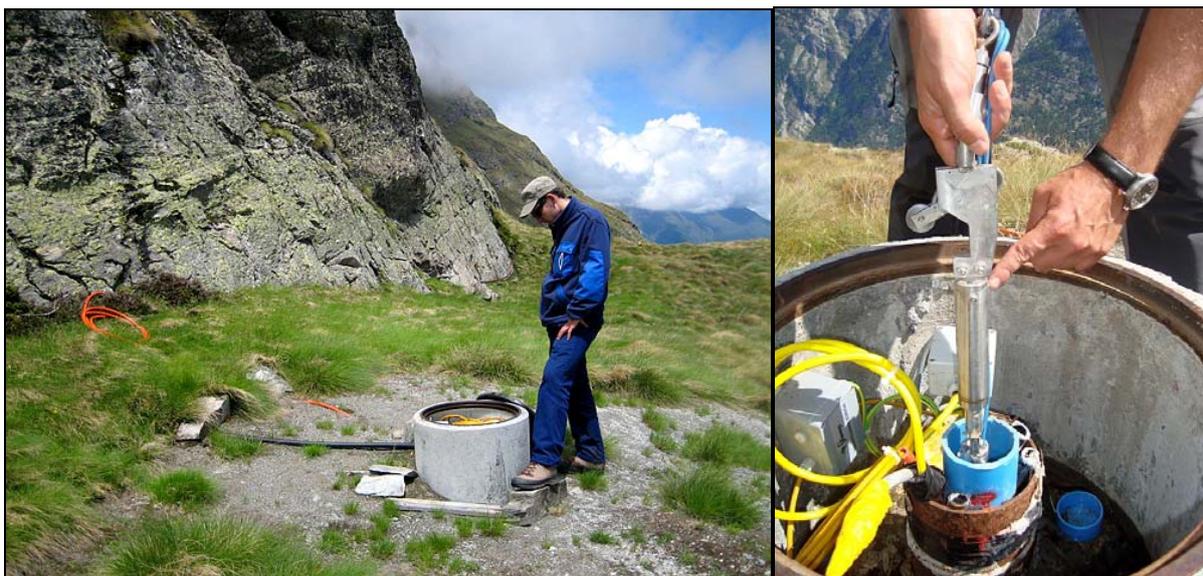
**Figure 8:** Borehole sb120 at Randa, showing the surrounding area and borehole top, and detail of the inclinometer casing and in-place inclinometer instrument.
